Damage to Abandoned Lignite Mines Induced by 2003 Miyagi-Hokubu Earthquakes and Some Considerations on its Possible Causes

Ömer AYDAN*¹

Abstract

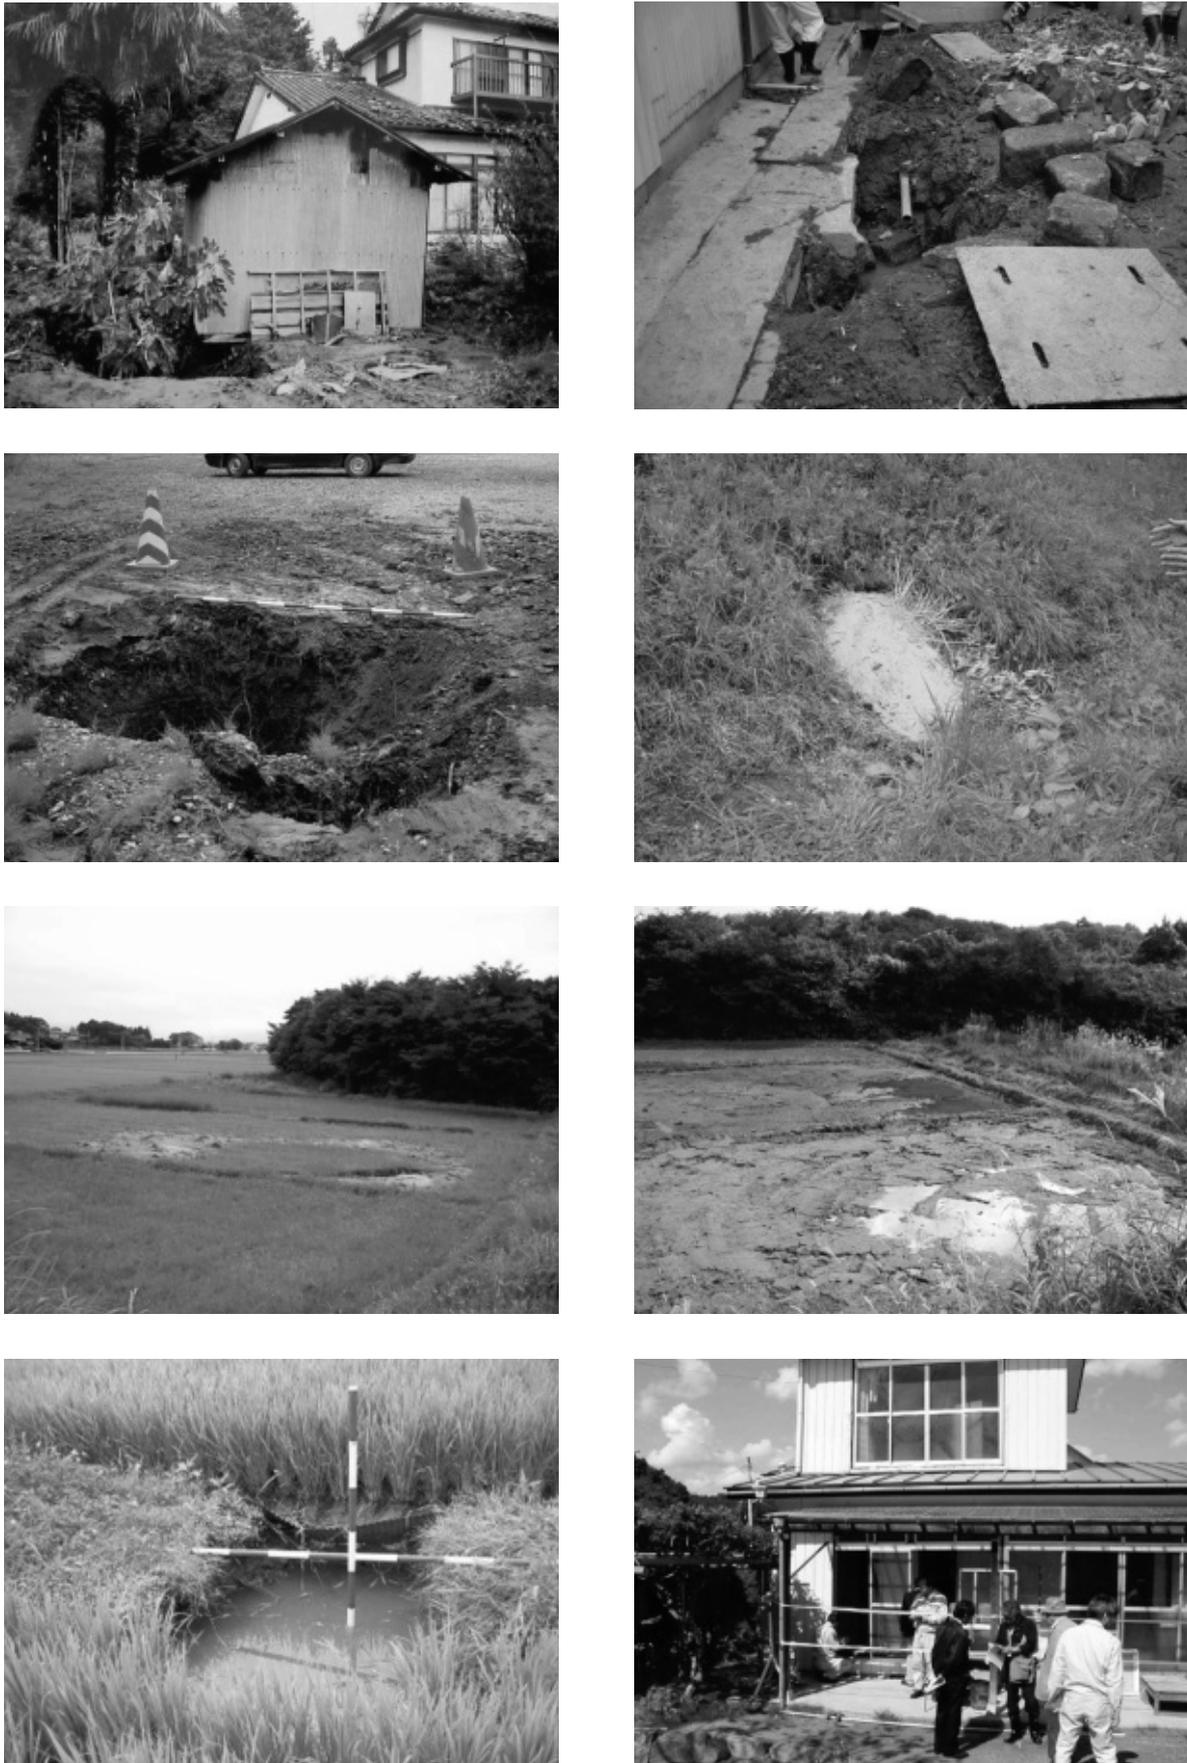
A peculiar liquefaction phenomenon was observed at the site shown in Figure 6. The liquefied ground at a rice-paddy over the abandoned-lignite mine workings looked like a do-nut. The local authorities informed that the pillar at abandoned-lignite mines had a square shape with a side length of 1.5-2m. The shaking table tests on room & pillar mines by the author indicated that the shaking was higher on the ground surface above pillars than the ground surface above the openings (Aydan et al. 2003). Therefore, the local differences in the shaking characteristics of the ground surface may play some roles on the peculiar form of ground liquefaction.

Figure 6: Caving and sand boiling in the area of Yamoto-town caused by the earthquake

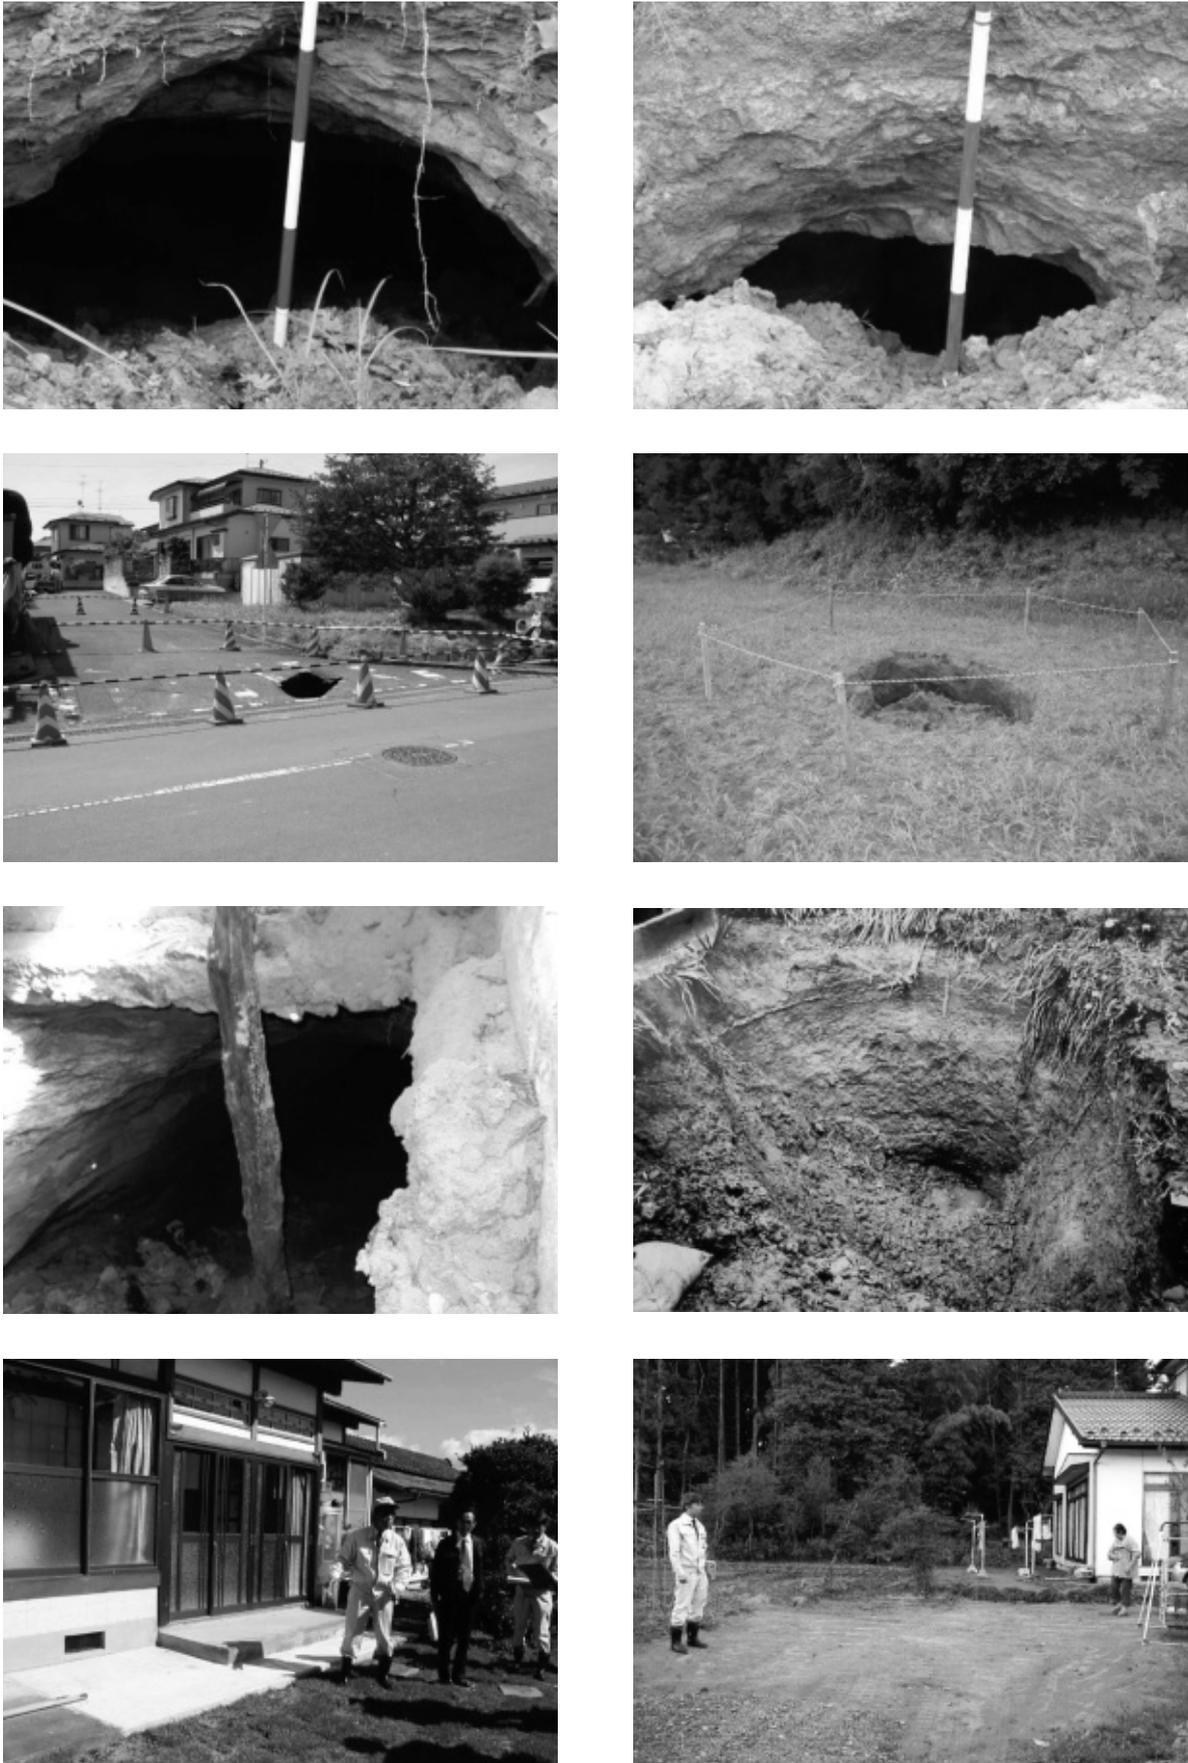
Figure 7: Caving and restoration

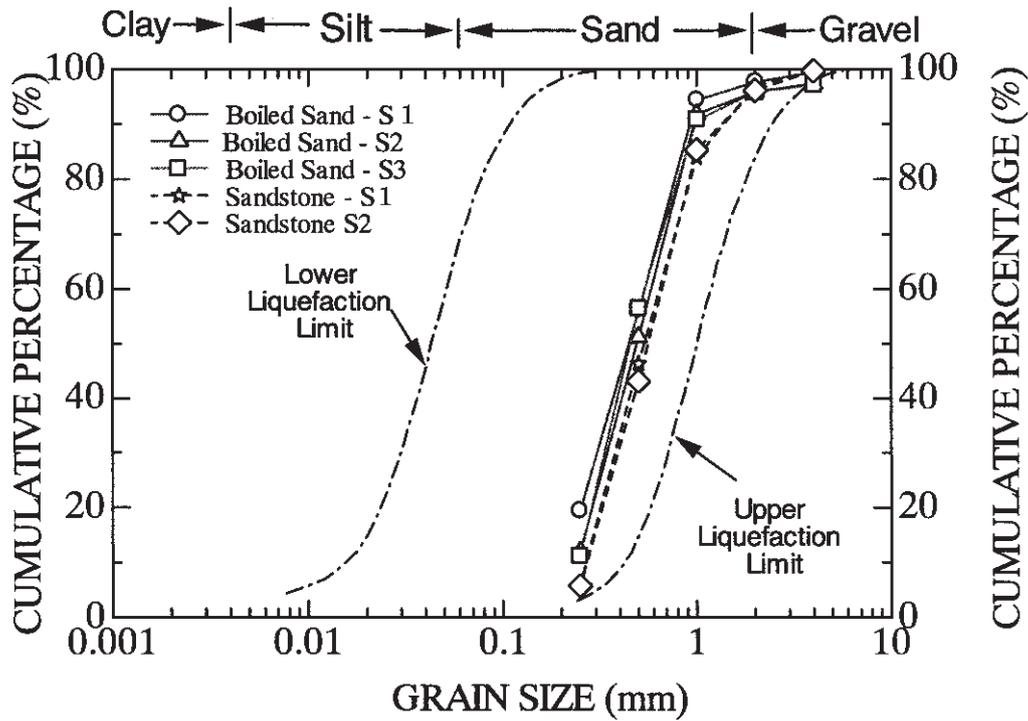
Figure 8: Grain-size distribution of boiled sand and sandstone at location No17.

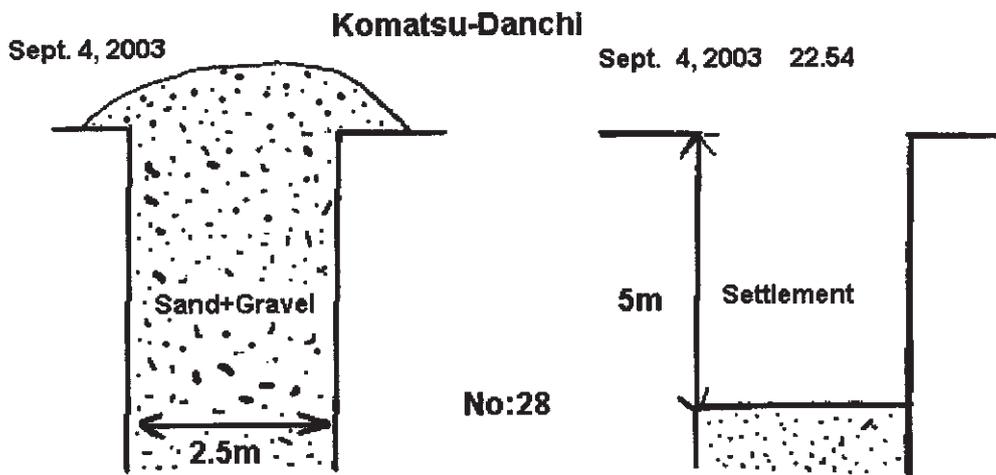
A peculiar settlement of filled sinkhole with a diameter of 2.5m occurred on a road in Komatsu-danchi, which is a bed-town for people working in Sendai City and it was filled with 120 tons of a mixture of sand and gravel (Figure 9). The filling material in the sinkhole was settled due to an aftershock with a magnitude of 3.6 at 22:54 on September 4. This aftershock was very close to the site and the maximum acceleration at Ishinomaki of K-Net strong motion network, which is 11 km away from the epicenter, was 48.5gal. Although the aftershock was small, very high ground accelerations observed during this small aftershock.

Figure 9: An illustration of the settlement of the filling material in a sinkhole

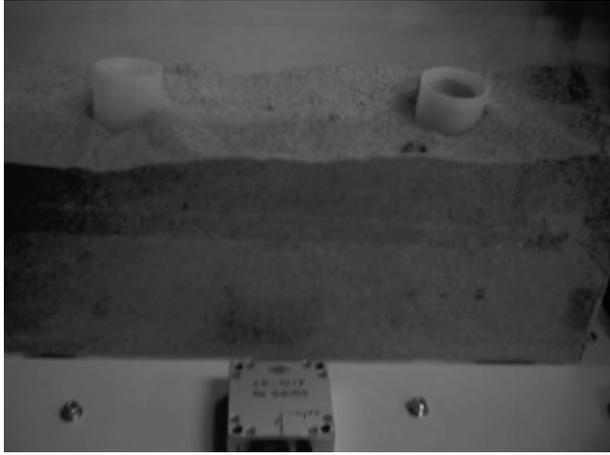
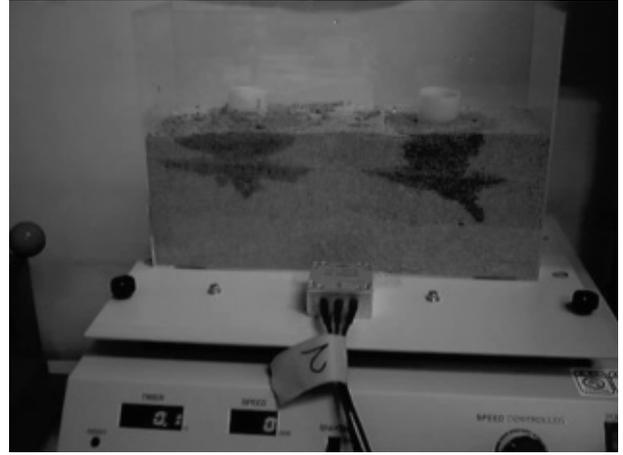
Figure 14: Views of the model preparation and after shaking in the first sloshing experiment

in Figure 14(a). The shaking was horizontal. In the first experiment, no instrumentation was used and the main aim was to see if sloshing phenomenon could occur or not. Figure 14(b) shows a view of the model after shaking. The experiment clearly indicated that sloshing phenomenon did take place and ground water was ejected to the ground surface through the vertical shafts.

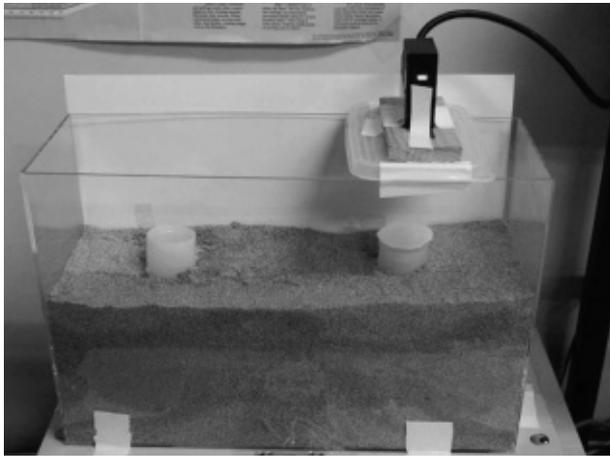
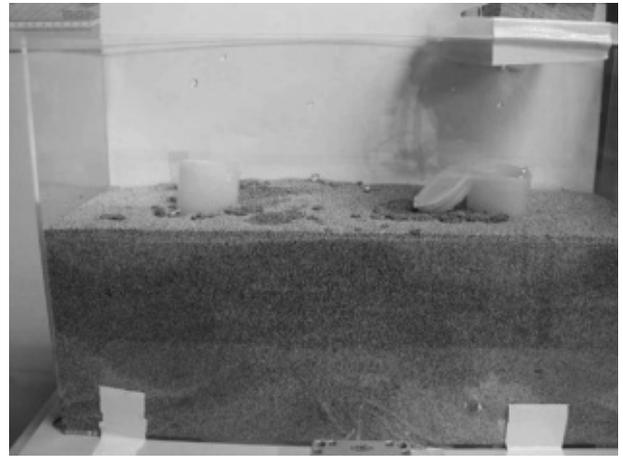
Figure 15: Views of the second experiment and instrumentation before and after shaking

Then the second experiment was designed to measure applied acceleration on the model. In addition, one of the vertical shaft had a lid and the motion of the lid was also measured during shaking (Figure 15). Figure 16 shows the base acceleration and vertical displacement of the lid. The motion of the lid starts when the base acceleration exceeds 300 gals and the lid was thrown by sloshing ground water in the vertical shaft when the acceleration level was about 900 gals. Figure 17(b) shows a view of the model after the shaking. Therefore, it can be firmly said that one of the causes of the appearance of the ground water nearby damaged areas is the sloshing (splashing) of ground water in submerged abandoned lignite mines.

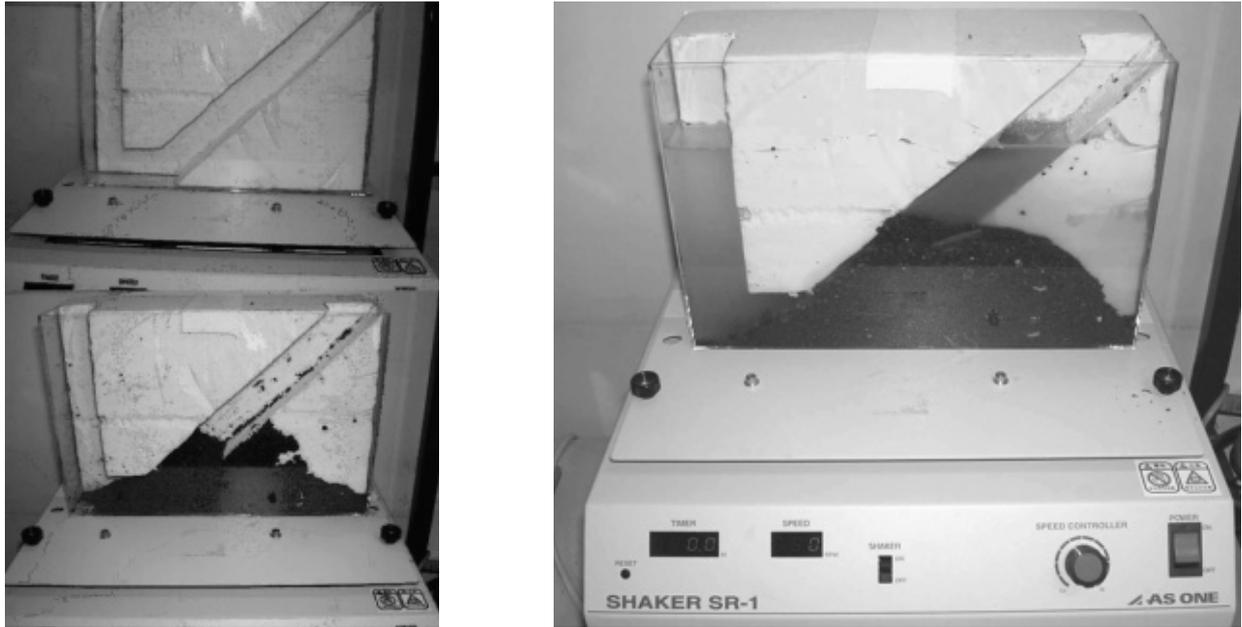
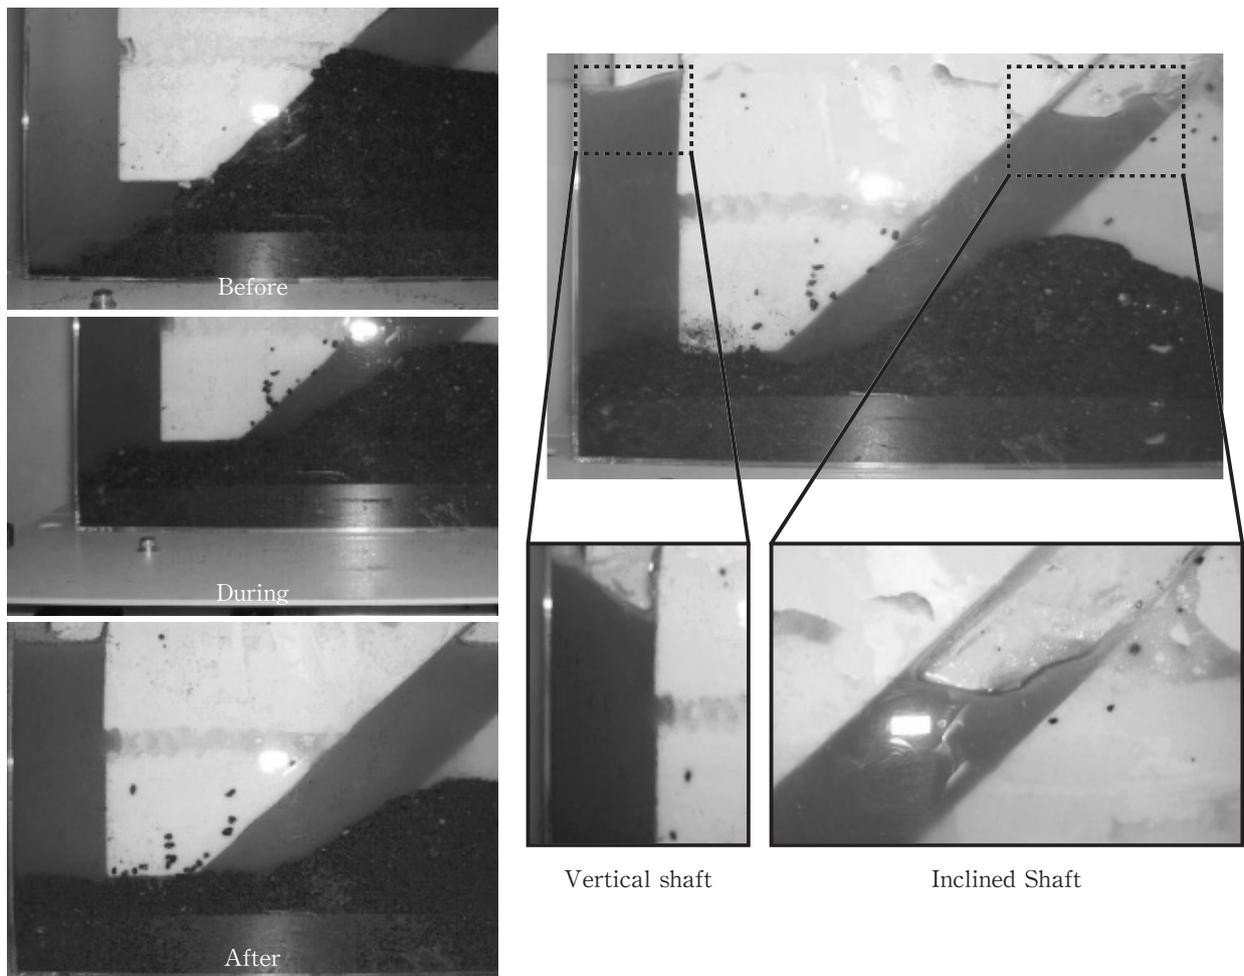
Figure 17: Views of the model test on blockage breach before, during and after shaking

The second series of experiments was concerned with the breach of the blockage of the fallen material in the underground opening (Figure 13). Figures 17 shows several views of the model before, during and after shaking. The experiment clearly showed that the motion of ground water can breach the blockage in the opening. This may imply that the ground water will appear on the ground surface at abandoned mines at lower elevations when the blockage in the abandoned mines with higher elevations having higher ground water table is

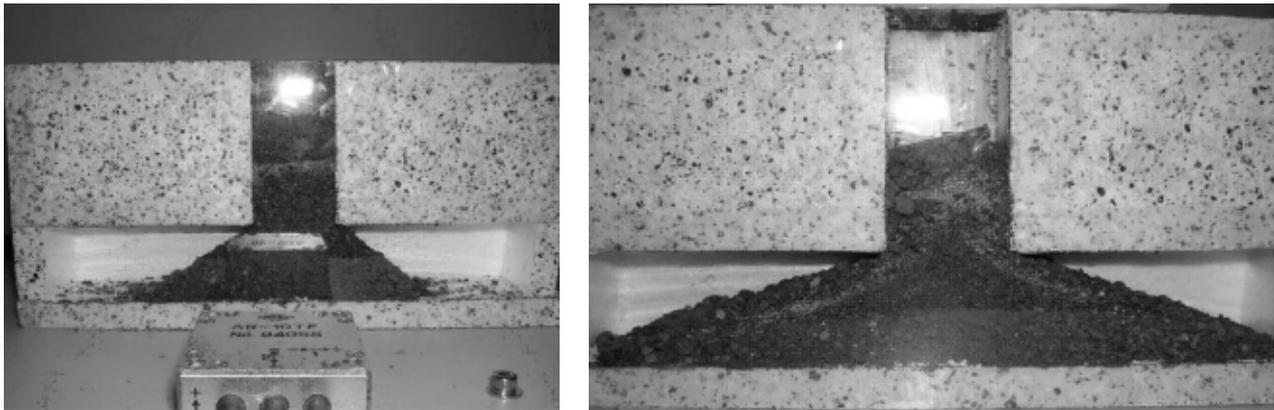
Figure 19: Views of the model before and after the shaking test

The model was subjected to shaking after the filling and set-up of the instrumentation. Figure 19 shows a view of the model after shaking. As noted from the figure, the filling material settled and flowed into opening. The settlement was almost the half of the sinkhole depth. Furthermore, the fine sand used for marking purposes flowed along a curved path. The final slope of the spreaded filling material was about 18-20°. The slope

angle seems to be in accordance with the stable slope angle for the applied maximum amplitude of the base acceleration.
