Damage to Abandoned Lignite Mines Induced by 2003 Miyagi-Hokubu Earthquakes and Some Considerations on its Possible Causes

Ömer AYDAN*¹

Abstract

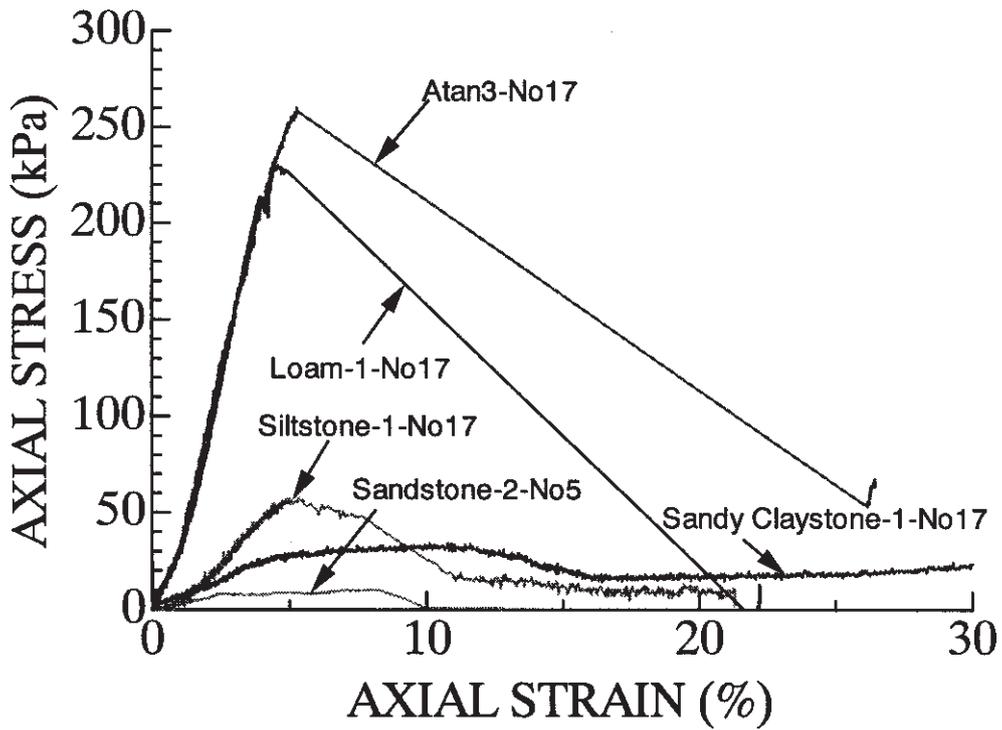
Figure 10: Typical uniaxial compression strain-stress relations for each rock group

Some chunks of in-situ rocks in the vicinity of damaged site were collected. Some samples were prepared in the form of prismatic blocks having a height/width ratio of 2. Some physical and mechanical properties of rock samples are listed in Table 3 and typical uniaxial compression strain-stress relations are shown in Figure 10. While lignite and loam samples show a brittle behaviour, sandstone, siltstone and claystone samples exhibit an elastic-perfectly plastic behaviour for a great range of uniaxial strain. The uniaxial compressive strength (σ_c) of rocks is remarkably low. This was thought to be weathering of rocks since rock blocks collected were on the ground surface being subjected to atmospheric conditions for a considerable period of time. Figure 11 compares the needle penetration index (NPI) versus uniaxial strength of Yamoto rocks together with other soft rock samples from different parts of the world.

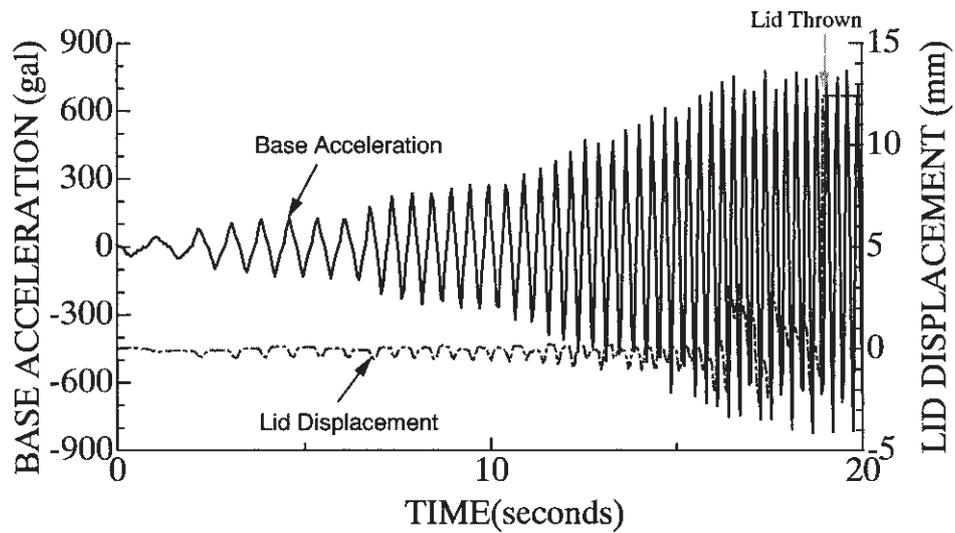
Figure 16: Measured base acceleration and the vertical displacement of the lid

Then the second experiment was designed to measure applied acceleration on the model. In addition, one of the vertical shaft had a lid and the motion of the lid was also measured during shaking (Figure 15). Figure 16 shows the base acceleration and vertical displacement of the lid. The motion of the lid starts when the base acceleration exceeds 300 gals and the lid was thrown by sloshing ground water in the vertical shaft when the acceleration level was about 900 gals. Figure 17(b) shows a view of the model after the shaking. Therefore, it can be firmly said that one of the causes of the appearance of the ground water nearby damaged areas is the sloshing (splashing) of ground water in submerged abandoned lignite mines.

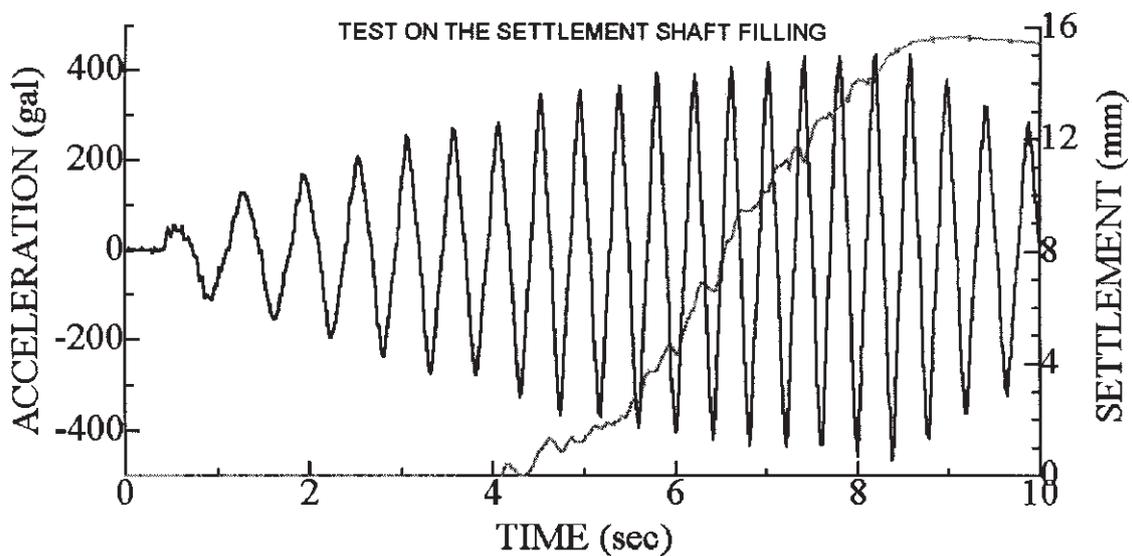
Figure 20: Measured base acceleration and the settlement of the filling material

Figure 20 shows the measured base acceleration and settlement response of the filled sinkhole. Due to some reflection problems, the laser displacement transducer at some intervals could not measure properly the settlement response. Nevertheless, the measured responses are sufficient to illustrate the overall behaviour of the filling material during shaking. Furthermore, the settlement was initiated when the acceleration was greater than 325gal. The observed behaviour of the filling material was quite similar to the observations at the actual site and can explain the physical background of the settlement problem. The amount of the settlement of the filling material depends upon the frictional properties of filling material, the maximum ground accelera-
